Investigate the Flatson Wear and Rolling Contact Fatigue of Wheel Materials

ABSTRACT: The rapid development of high-speed railways led to wheel damage. This problem was more prominent at wheel abrasion, which is a more serious type of wheel damage. Therefore, to ensure the safe operation of the vehicle, the study of the formation process of the wheel abrasion and the influence of the abrasion on the vehicle operation has very important significance and practical value. In this paper, investigate the braking process of the vehicle under different influencing factors are prefabricated using rolling contact fatigue tests. Through various analysis methods, the formation mechanism of abrasions and the influence of different abrasions on wheel operation were studied. The result shows that the abrasion area will form a severe plastic deformation layer and a Martensite white layer mainly caused by thermal influence. Running a wheel with abrasion will cause greater wear, and it will have a serious impact on the life of the wheel, and the surface of the scratch area after rolling has different surface damage morphology.

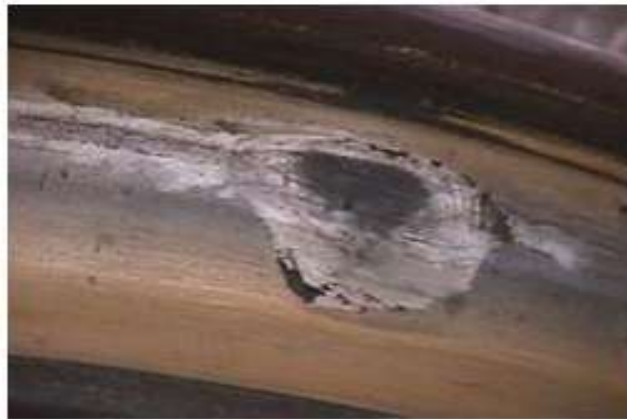
Figure 1. Wheel tread abrasion [8]

Generally, a wheel/rail abrasion is classified into a wheel abrasion and a rail abrasion. This article focuses on wheel abrasion, so only wheel abrasion is introduced. As shown in Figure 1, wheel abrasion often occurs on the rolling surface of the wheel; that is, the wheel tread, which is also commonly referred to as wheel tread abrasion. Many works of literature call it wheel flat scars based on their special shape [15-17].

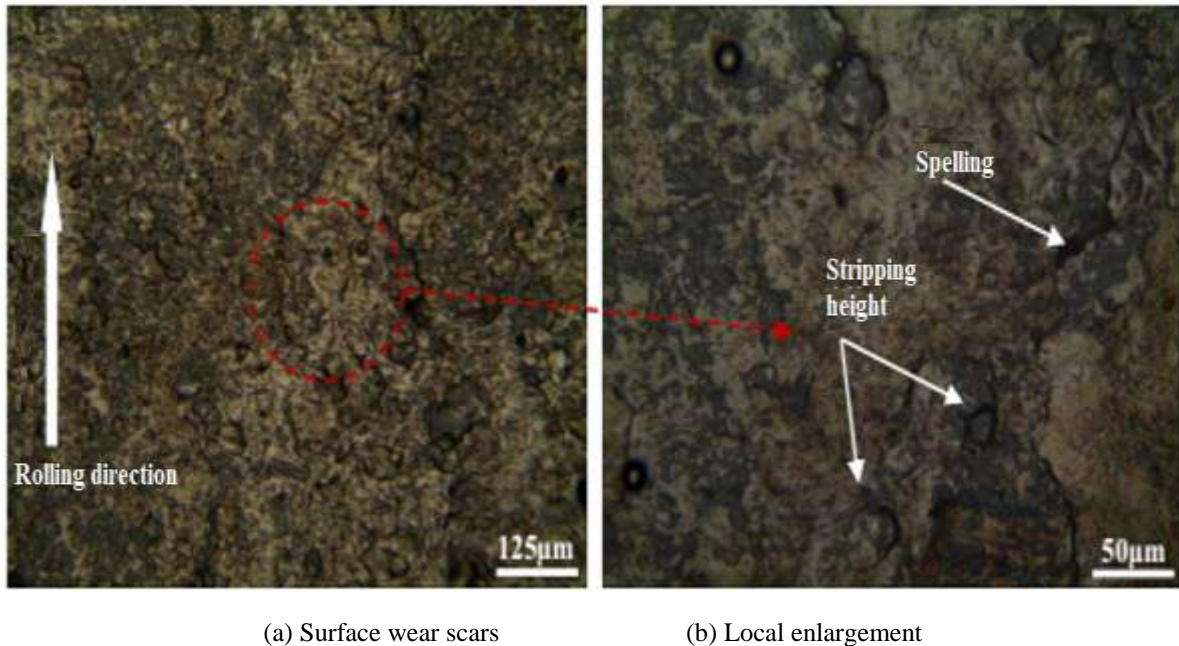
Figure 6. Surface morphology of specimen F1

Figure 6 is the surface damage map of sample F1. From Figure 6 (a), it can be seen that because sample F1 has only been subjected to the conventional rolling contact fatigue test, no other special treatment has been performed, and its surface has not appeared. Abnormal damage after zooming in on a part of it (Figure 6 (b)), it can be seen that the surface of sample F1 is mostly small peeling pits and some peeling and peeling, which are all minor damage caused by typical wheel fatigue tests. Damage does not have an abnormal effect on the life of the wheel and belongs to the normal range of fatigue damage.

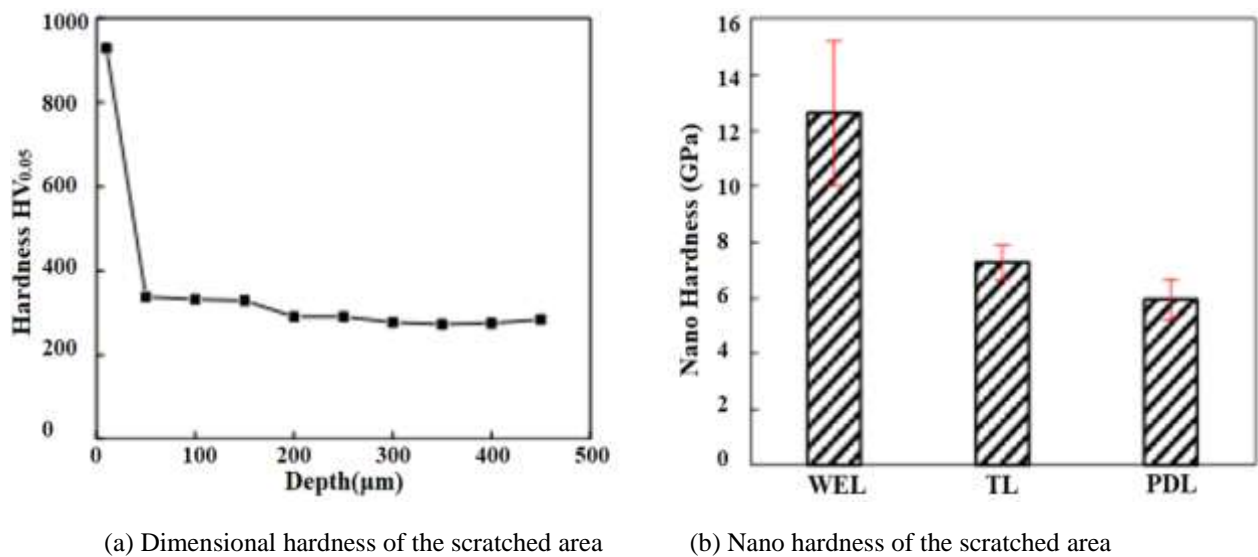
**Figure 9.** Cross-section hardness of the scratched area of the wheel specimen

In order to more accurately determine the hardness gradient in the white layer profile area, the nanohardness of the white layer, the transition layer, and the plastic deformation layer of the sample was then measured using a nanohardness meter. Figure 9 shows the measured nanohardness of the three layers of the white layer, transition layer, and plastic deformation layer are 12.6GPa, 7.3GPa, and 5.9GPa, respectively. The hardness of the white layer is also the same as that of previous scholars. The measured hardness of the white layer [24]. Because the transition layer is a mixed layer of white layer structure and ferrite, its hardness value is also higher than that of the plastic deformation layer. The hardness value from the section also shows that the white layer formed in the test should be a white layer.

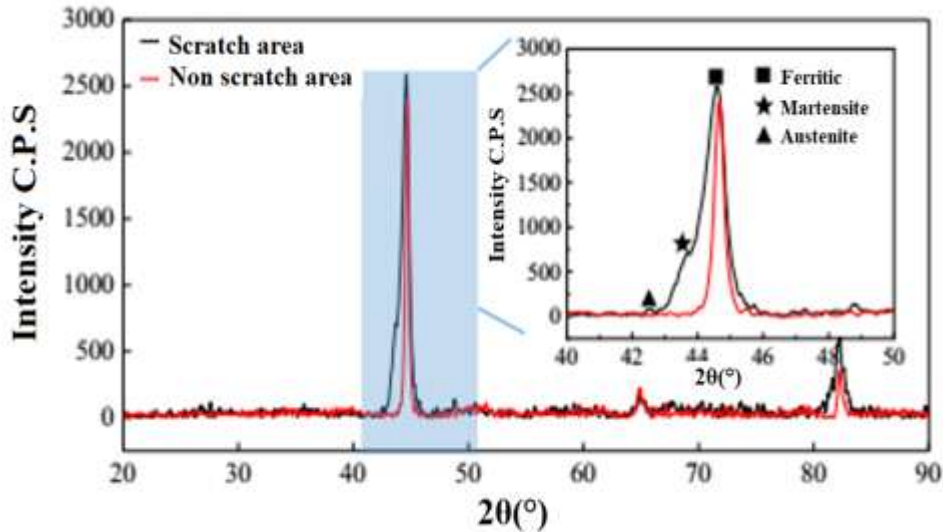
Figure 10. XRD comparison chart of the scratched and unscratched areas of the wheel sample

In order to further prove that the white layer formed in the abraded area in the test is a white layer, an X-ray diffraction analysis (XRD) was performed on the abraded area of the sample to determine the composition of the abraded area structure. The XRD analysis results of the injury area are used for comparison. Figure 10 is the XRD result map, where black represents the scan result of the abraded area, and red represents the result of the abraded area. Enlarging the area of 40° ~ 50° shows that martensite and austenite exist in the tissue of the

abraded area. And no abrasions in these areas. Combined with the surface and section hardness values of the abraded area in the previous section, it can be determined that the white layer that appears in the sample is the white layer. And because the existence of residual austenite was found in the XRD analysis, this can prove that the formation mechanism of the white layer formed in this test is formed by the influence of heat, not by the plastic mechanism, only under the influence of heat martensite formed under the mechanism will have residual austenite [25-27].

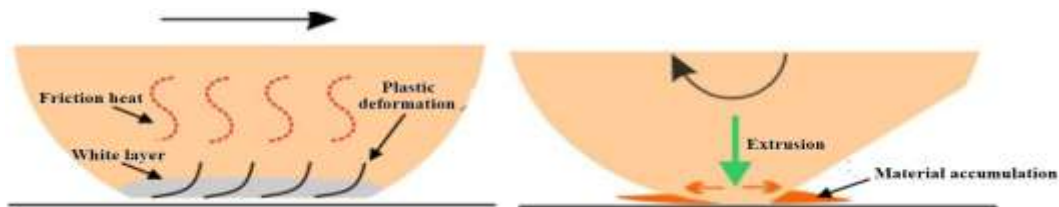
Figure 11. Mechanism of scratch formation and operation process

According to the test results and analysis of the appeal, in order to more intuitively show the formation process of the wheel abrasion and the influence rule of the abrasion on the wheel operation, the abrasion effect mechanism diagram of Figure 11 was drawn. Figure 11 (a) shows the process of abrasion formation. Wheels are locked during emergency braking, which causes sliding between the wheel-rail interface. Under strong mechanical action, the surface tissue of the abrasion area undergoes severe plastic deformation. At the same time, the heat generated by the friction caused the temperature of the abrasion zone to rise sharply, causing the surface structure to undergo a phase change, forming a white layer [28]. Wheel abrasion damages the wheel's geometry and forms a flat surface. As shown in Figure 11 (b), when the wheel continues to roll again, the front of the abrasion area is in contact with the rails. Because the edge of the abrasion area forms a sharp corner, stress occurs at the sharp corner, which makes the rubbing. The material at the front of the scratch area is squeezed to both sides, and continuous rolling and squeezing causes the material to accumulate there [29]. This phenomenon can also be observed in the above test results. As shown in Figure 11 (c), after the wheel comes into contact with the front of the abrasion, the wheel takes off due to the rotating inertia. The middle of the abrasion area and the contact surface of the rail briefly separate, and then the wheel continues to rotate and falls, forming a large impact on the back of the abrasion zone [30] (Fig. 11 (d)), this impact causes the original small thermal cracks to expand, and due to the brittleness of the white layer Under the influence of external force, the white layer at the back of the abrasion area is easily broken to form cracks. These cracks further expand to the substrate under this continuous impact, and finally form more severe long cracks, which seriously affects the service life of the wheel and even affects Driving safety, this is also the reason why larger angle cracks can be observed at the rear of the abrasion area after the test.
