Microstructural Evaluation for TIG Welding of AA6061-T6 using ER5356 Filler Metal; in Postweld and as-Weld Treatment

ABSTRACT: AA6061-T6, as a heat treatable alloy, is a sensitive alloy to any thermal cycle. Heat can be imposed to AA6061-T6 during tungsten inert gas welding (TIG) and the microstructure of alloy can be affected subsequently. The purpose of this study is to evaluate the microstructure of as-weld and postwelded samples. Heat affected zone (HAZ) in two different temperatures (solution and aging temperature) in as-weld sample was revealed. Microstructure and hardness were restored in AA6061-T6 by applying post weld heat treatment (PWHT), however, liquid cracking (LC) was found in partial melted zone (PMZ). Whereas filler metal-ER5356- was not a heat treatable alloy, however, its microstructure was changed from a dendrite one to equiaxed grains with closed boundaries and displayed higher hardness from (60) HV to (80) HV due to the post weld heat treatment (PWHT).

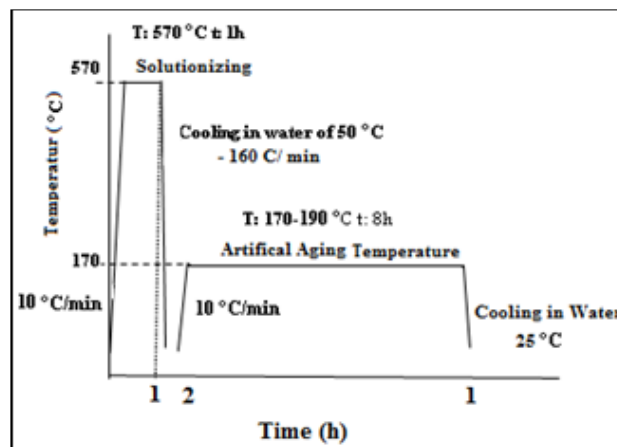
To assess the influence of heat treatment on the microstructure and mechanical properties of joints, PWHT was done on the welded samples. The heat treatment procedure was conducted according to what comes from metals handbooks (Vol. 4, Heat Treating) [8], as shown in “Figure 2”.

Figure 2. T6- heat treatment cycle performed on the TIG samples [8].

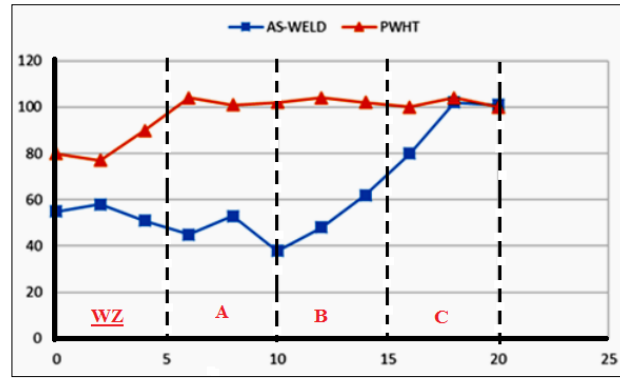
“Figure 4”, shows micro hardness tests were carried out along the central line of the weld in as-weld and (PWHT) samples. As already mentioned, the (HAZ) in (TIG) welded joints of heat treatable aluminum alloys are included 2 parts (including solution area and over aging area). The minimum hardness belongs to over aging division in (HAZ) of as-weld sample with (38) HV hardness. Whereas the minimum in (PWHT) is almost (78) HV in (WZ). It means that (PWHT) can efficiently return this property.

Figure 4. Microhardness of As-weld and PWHT samples (WZ, A, B and C are in agreement with Figure 1).

The filler metal is (5356), though. In this non-heat treatable filler metal, hardness was changed from 60 HV to 80 HV in as-weld and (PWHT) consequently.

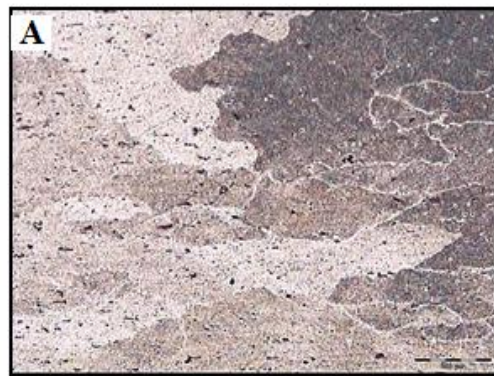
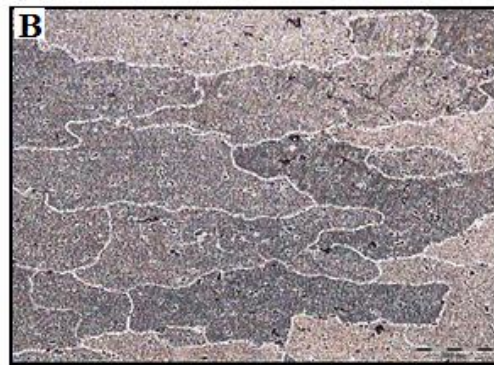
HAZ is displayed in “Figure 5”. Whereas “Figure 5A” shows the (HAZ) in as-weld sample which is close to the weld region that experienced higher temperature (solution temperature). Thicker grain boundaries that are caused from immigrated depositions (due to solution of deposition) are pointed in light lines in this picture. On the other hand, over aged division is seen in figure 5b which indicates thinner or no grain boundaries in some areas. It also shows greater second phases due to precipitation coarsening [2,4,10]. The transformation from (β'') to (β') and finally β (Mg_2Si) precipitates occurred because of an extensive and frequent thermal cycle of (TIG) welding. These results are regular with the earlier studies published by researchers [2,4].

Figure 5. Optical microstructure of HAZs, a) HAZ of solution area, b) HAZ of overaged area, c) HAZ after PWHT.

Restored (HAZ) microstructure after (PWHT) can be seen in “Figure 5C”.

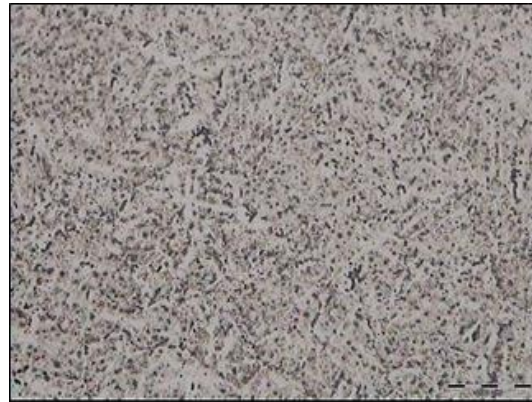
The dendritic microstructure is formed in the center of (WZ) of as-weld sample “Figure 6”. The main reasons for this nonstructural texture are high solidification and cooling rate, although, our welding procedure had a preheat. Previous studies that used (Mg) rich filler metals in welding of aluminum alloys stated this type of microstructure [11,12].

Figure 6. Optical microstructure in WZ of as-weld.
